DISTRIBUTION AREA: REGION OF THESSALY

«Damage to an insulating connector at the Distribution Network Entry Point, North Larissa - Emergency supply of an industrial customer with CNG»

2nd Preparedness Drill – Safety of Supply _License Area

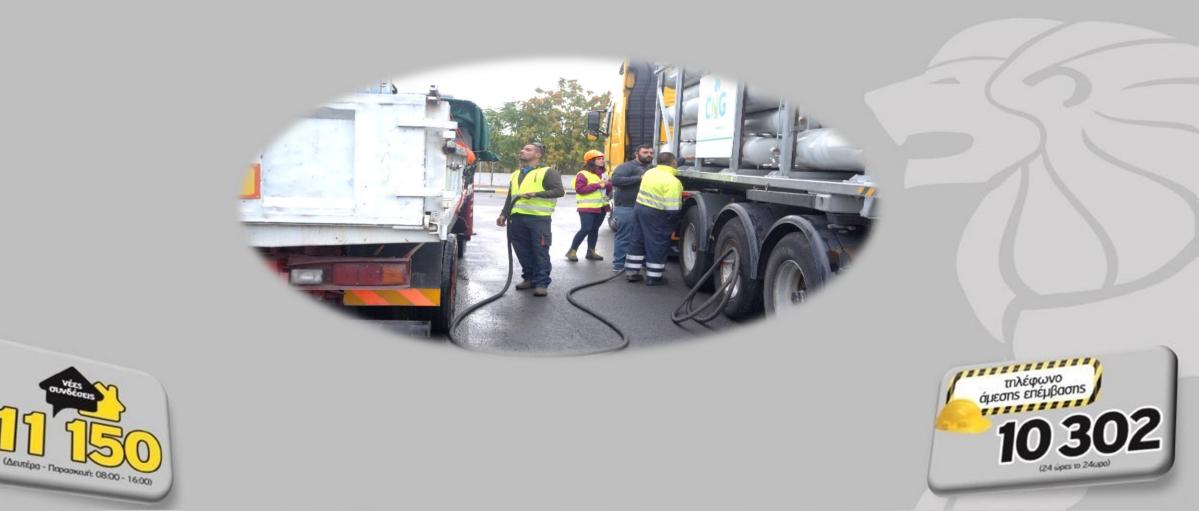
> Audit on the CNG trailer, the decompression cabin and the contractor's CNG transport equipment, was performed.

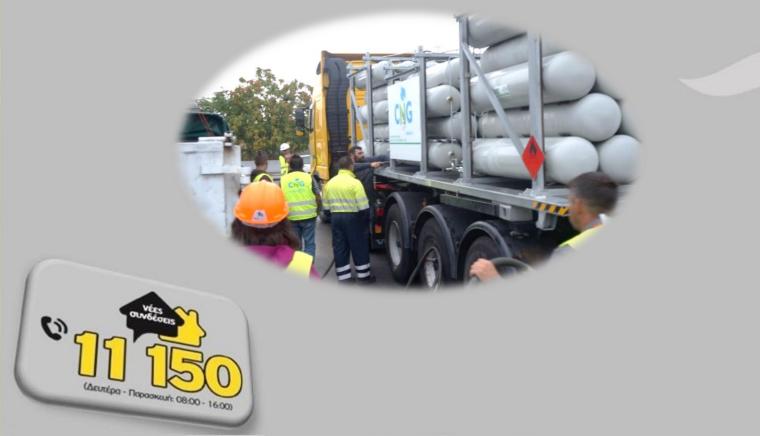
Moreover, a test on the functionality of the CNG decompression cabin was performed for detecting possible leakage or possible damage on the heating boilers, the regulators etc.

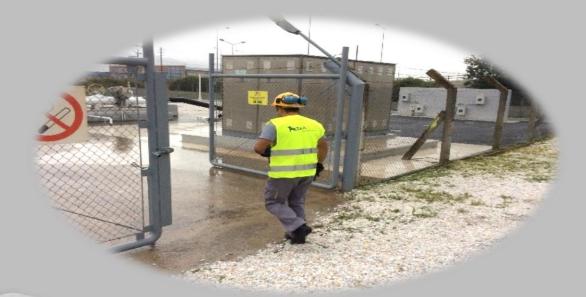
EDA THESS' technician discovers a rupture on the insulating connector at the Distribution Network Entry Point, which is located on the Northern part of Larissa. He also discovers a gas leakage and takes all the necessary safety measures on the area.

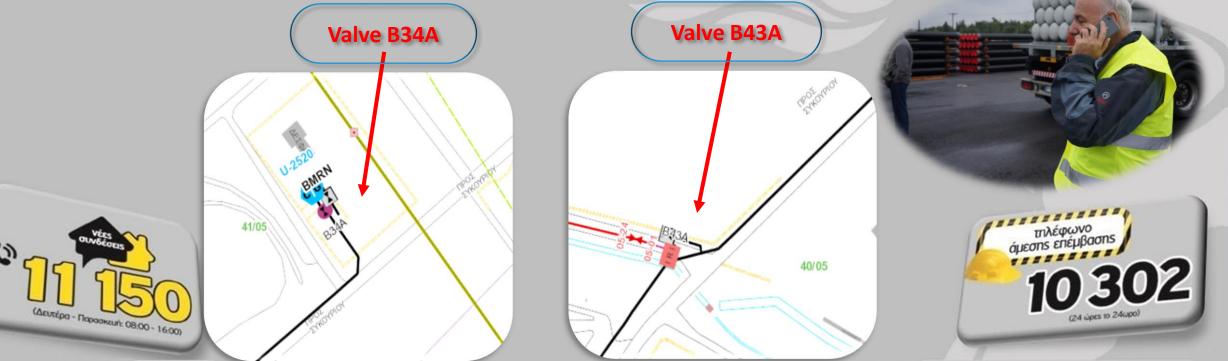
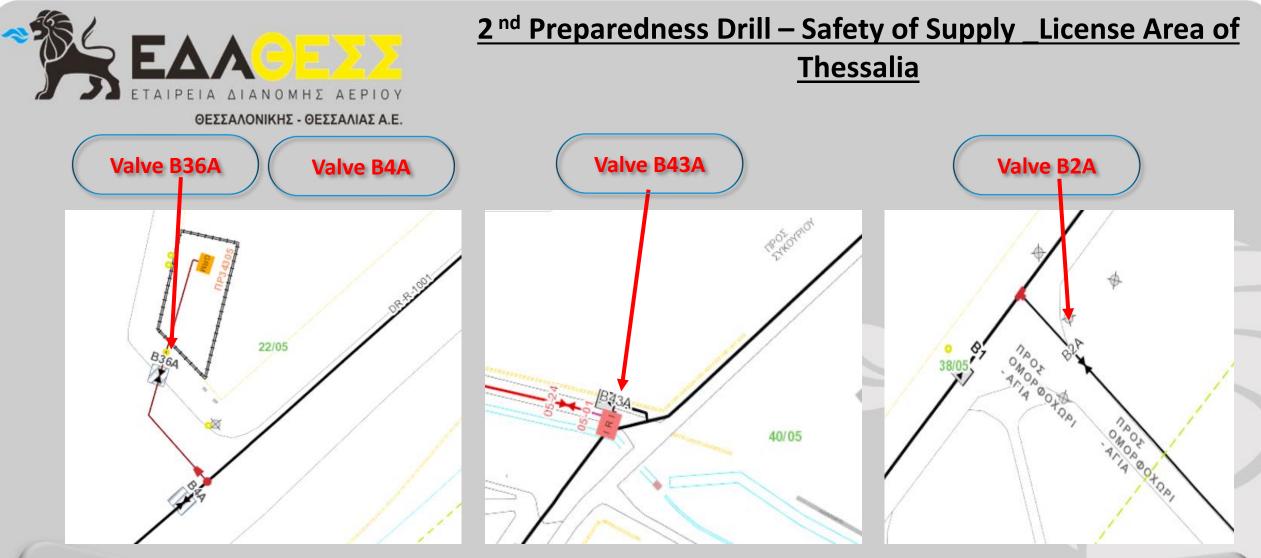
- Слеите́ро Парадокецті: 08:00 16:00)
- > Points of EDA THESS' interventions to close the main valves.

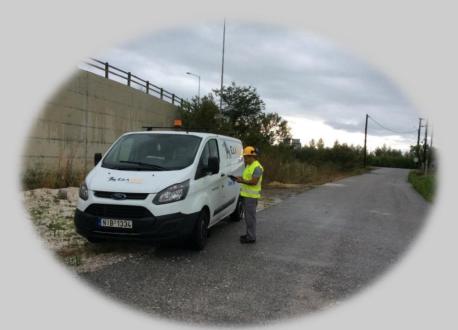
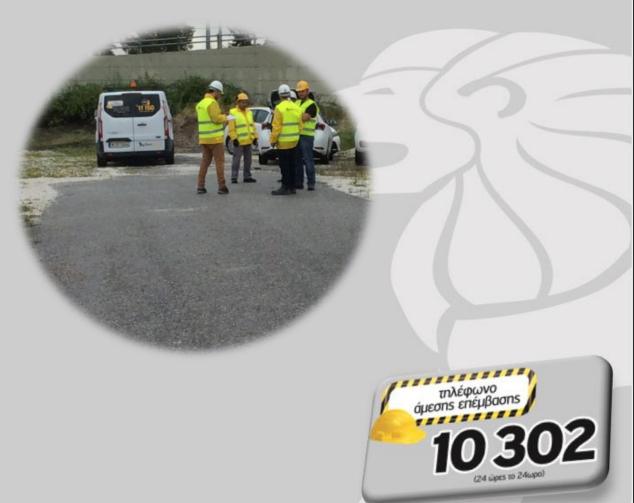
At 07:53 a.m. the CNG trailer consisting of 78 gas cylinders (175 bar and 2.925 m³ total pressure), the decompression cabin vehicle and the contractor's personnel Transport Vehicle, are heading to the concerned area.

CNG Trailer

Decompression cab

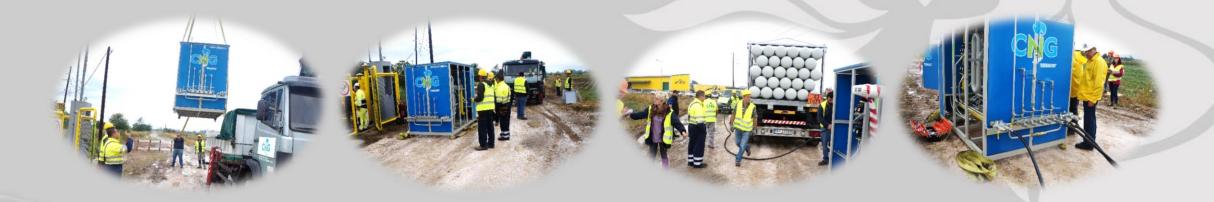
- > At **08:50 a.m.** all preliminary works for the supply with compressed natural gas (CNG), begin:
- Placing safety markings on the entrance of the IRI station 05-01.
- Unloading the decompression cabin on the ground, next to the IRI Station 05-01, by using lifting machinery.
- Installation of low and high pressure hoses , for connecting the trailer with the decompression cabin.
- Installation of appropriate grounding.

• Checking and testing the functionality of the CNG equipment.

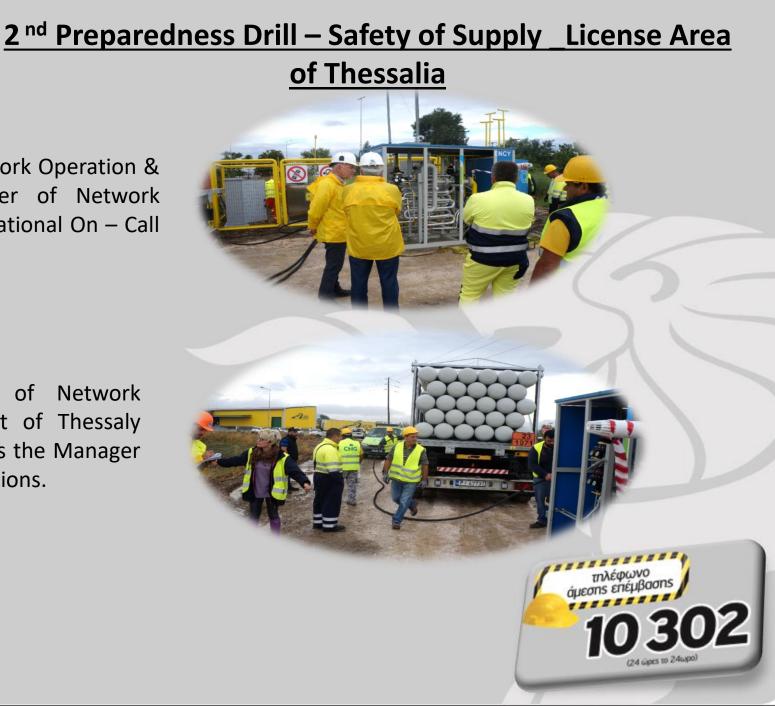
- > At 09:20 a.m., the contractor's CNG Emergency Intervention Team begins all relevant works for the gas supply with CNG.
- The compressed natural gas (CNG), initially enters the decompressor cabin via hoses at pressure of 100 bar, in order to detect possible leakage and then the pressure gradually increases up to 170 bar.
- The natural gas is being preheated to proper temperature with gas boilers (rising the temperature of the water) and through heat exchangers (water – natural gas).
